Report on the outcomes of a Short-Term Scientific Mission¹

Title: "Optimisation of the use of Pleco[®] to locally and safely clean the tarnishing developing on sterling silver heritage artefacts"

Location: Empa's Joining Technologies and Corrosion Laboratory, Dübendorf, Switzerland

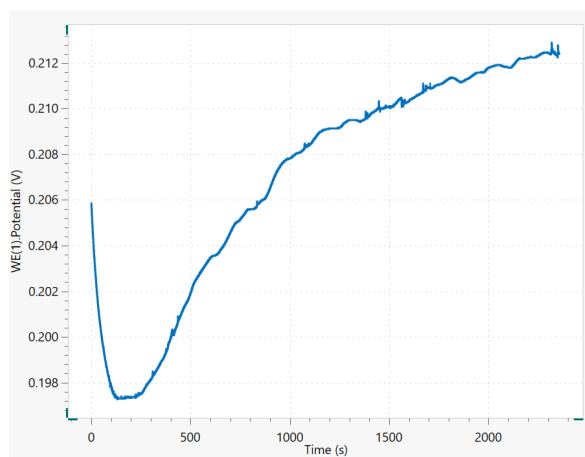
Figure 2. OCP of glassy carbon in KNO_3 , 1% (w/v), pH 6; WE: GC; RE: Ag-AgCl 3M; CE: Pt wire, © Ricotta Nicola & Gonzalez Frutos Jorge.

- measure the potential of the glassy carbon (GC) electrode employed as a reference electrode (RE). In fact the GC is not a real RE and it is important to check its potential before and after polarization. The potential of the GC was about 210 mV/Ag-AgCl (a value that is within the average of the values measured outside this STSM) (Fig. 2):

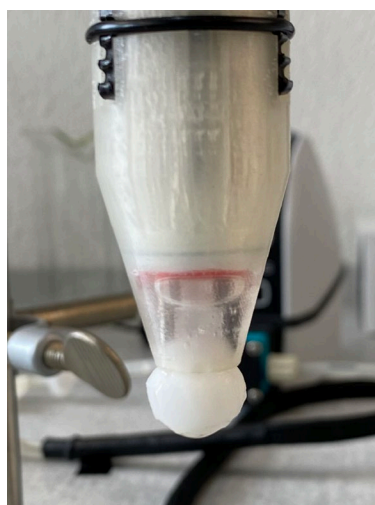
Figure 3. Shape and size of the pad, © Ricotta Nicola.

- set measurement parameters so that current fluctuation in the plots (due to the change in contact area between the electrolyte and the metal surface being analysed) is minimized. Among the most important parameters are the sealing conditions of the Pleco electrolytic cell (10 cm of Teflon around the piston head and silicone hoses around the RE and CE), the electrolyte supply and extraction values (S 10 and E 45 mL/min.), and the shape and size of the pad (1.5 cm diameter and height and rounded tip) (Fig. 3). The above parameters were adjusted through the visual observation of the electrolytic cell (verifying that bubbles during pumping come from the pad and not from piston head, insuring then good sealing conditions) and of the pad (should not be too dry while preventing any leakage of electrolyte as drops); then by performing LSV measurements (on Ag925 coupons, from the ASTEC² project, tarnished by exposure during 48h to vapours produced by boiled eggs). At the end of each polarization, the pad was rinsed by stopping the extraction pump for about 1 min. The parameters remained unchanged for the rest of the experiments.

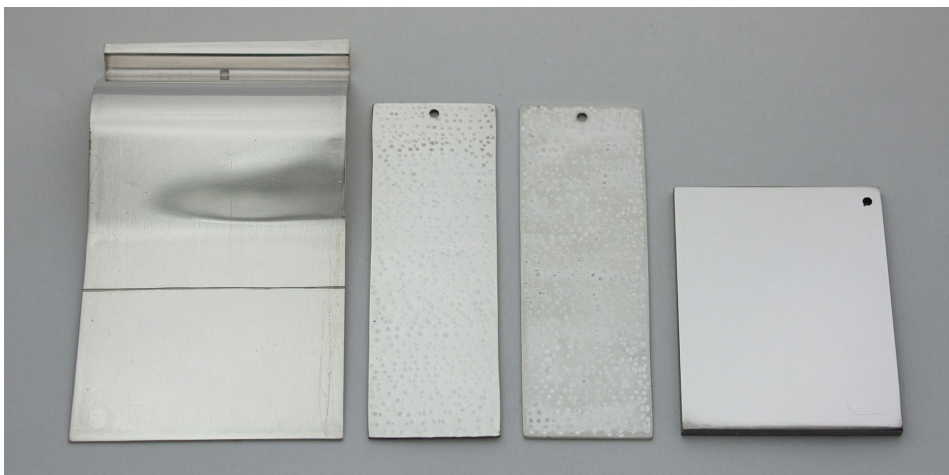
Figure 4. Coupons before artificial tarnishing, from left to right: curved and mirror; flat, punched and mirror; flat, punched and matte; flat and mirror, © Ricotta Nicola.

All measurements were performed on sterling silver coupons (Ag925) but with different surface finishes: curved and mirror; flat, punched and mirror or matte from Nicola Ricotta's PhD project; flat and mirror from ASTEC's project (Fig. 4). In addition, to simulate the surfaces of the artistic artifacts, the coupons were tarnished by exposure to vapours produced by boiled eggs while still warm for durations of 1, 2, or 48h (to obtain different levels of tarnishing) inside an 11L desiccator and with the presence of a small fan to homogenize the concentration of H_2S (Figs. 5 and 6).

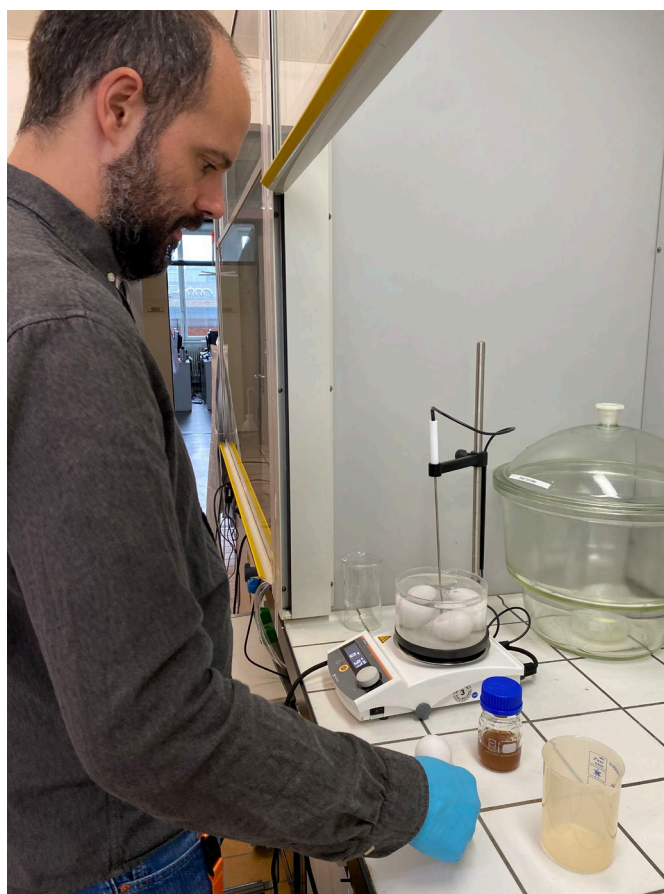
Figure 5. Jorge Gonzalez Frutos during the preparation of boiled eggs for tarnishing coupons, © Ricotta Nicola.

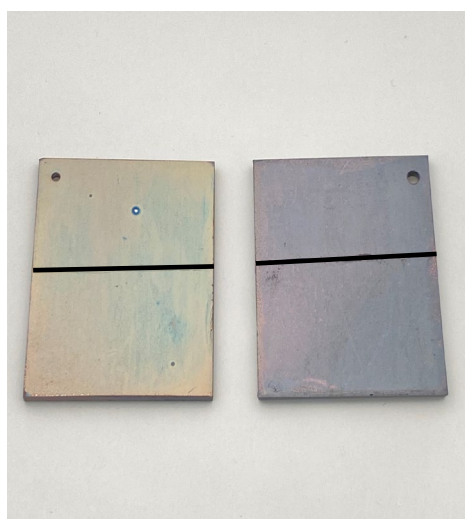
Figure 7. Left coupon tarnished for 1h and right coupon tarnished for 48h. Above black line: untreated area and below: Na₄-EDTA treated area, © Ricotta Nicola.

- 3% Na₄-EDTA at pH 10 (adjusted by the addition of HCl diluted to 37%) gelled by 4% agar-agar and applied on the coupons for 30'. Before and after gel application no particular difference is observed on the coupons (Fig. 7). The Na₄-EDTA solution and the time taken are not sufficient to achieve good chelating action and the Cu₂S peak is still present in the LSV plots (Fig. 8);

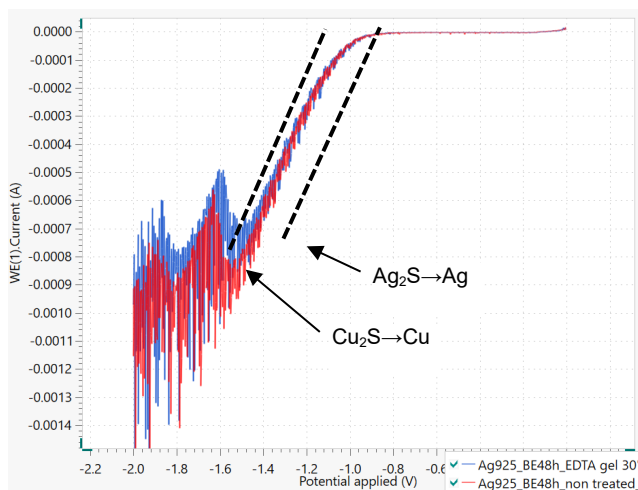
Figure 8. Red plot on an untreated area; blue plot on a Na₄-EDTA treated area, © Ricotta Nicola, Degriigny Christian, Gonzalez Frutos Jorge.

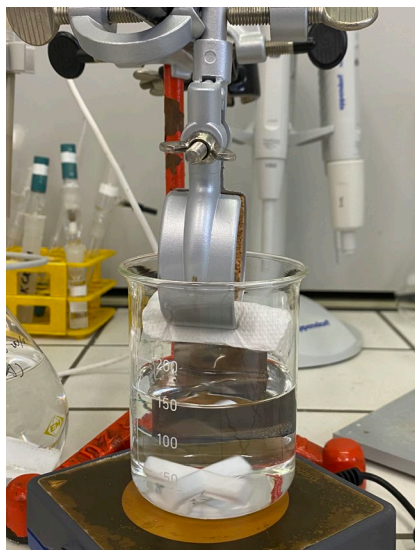
Figure 9. Coupon half immersed inside Na₂-EDTA made alkaline, © Ricotta Nicola

- 5% Na₄-EDTA at pH 10 (Na₂-EDTA adjusted by addition of 5M NaOH) in free form and by coupon immersion for 15h (Fig. 9). Unlike the previous case, Na₂-EDTA made alkaline succeeds in chelating copper corrosion products (Fig. 10);

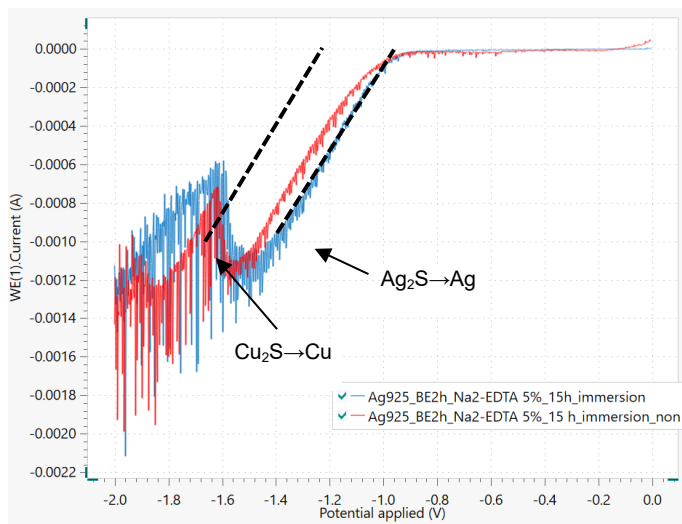
Figure 10. Red plot on an untreated area (with Cu₂S peak); blue plot on a Na₂-EDTA made alkaline treated area (without Cu₂S peak), © Ricotta Nicola, Degriigny Christian, Gonzalez Frutos Jorge.

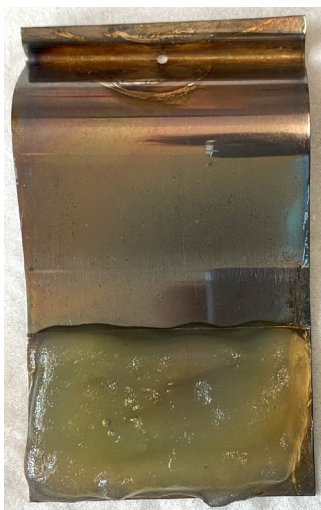
Figure 11. Coupon with Na₂-EDTA gel made alkaline, © Ricotta Nicola.

- 5% Na₄-EDTA at pH 10 (Na₂-EDTA adjusted by addition of 5M NaOH) gelled with 4% agar-agar and applied on the coupons for 18, 20 and 38h (Fig. 11). Only after 38h was it possible to remove the copper-based corrosion products as in the previous case of the coupon immersed in solution (Fig. 12).

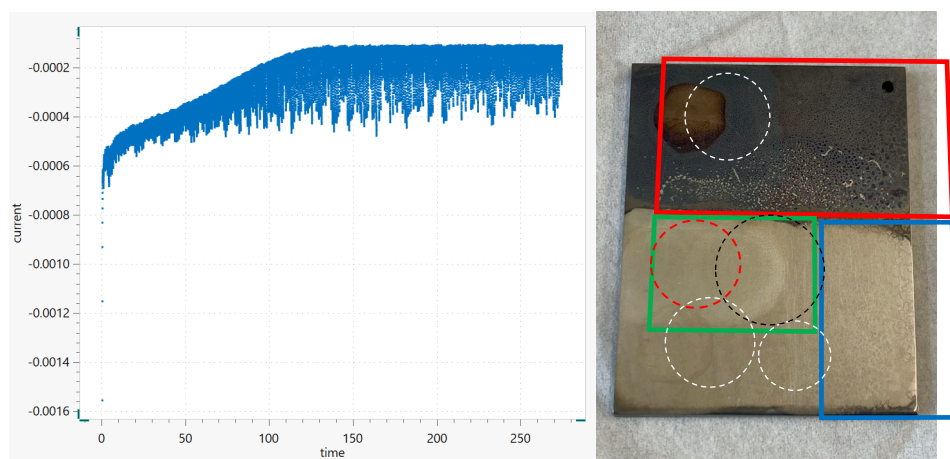
Figure 13. Chronoamperometry on a Ag925 coupon treated with 5% $\text{Na}_4\text{-EDTA}$ pH 10 in immersion for 15h. After polarisation at -1.2 V/GC and during 120s, it was possible to reduce the tarnish on the coupon as is highlighted by the blue rectangle. In addition, an untreated area (highlighted in red) and an area treated with a potential of -1.8 V/GC (highlighted in green) can be seen on the coupon. The -1.8 V/GC potential corresponds to a value that goes beyond the Ag_2S reduction peak to test the overcleaning effect (the surface indeed looks cleaner than the area treated with a -1.2 V/GC potential). The spots that can be observed on the coupons are due to LSV measurements with a potential scan down to -2 V/GC (white circles) and to chronoamperometries at a potential of -1.6 V/GC (red circle) and -1.8 V/GC (black circle), © Ricotta Nicola, Degriyng Christian, Gonzalez Frutos Jorge.

Another important analytical parameter investigated by chronoamperometry measurements was the time required for silver tarnish reduction, which also determines its thickness (Fig.13). The potential of -1.2 V/GC , in the specific case of the coupon analysed, corresponds to the middle of the Ag_2S reduction peak. This new cleaning protocol aims to limit the abrupt reduction of Ag_2S in Ag and the possible saturation of the pad with sulphur species that could create secondary effects on the metal surface (re-tarnishing, staining). As a result, the reduction is not immediate: there is a plateau after which the reduction is completed (visible after 120 seconds on figure 13).

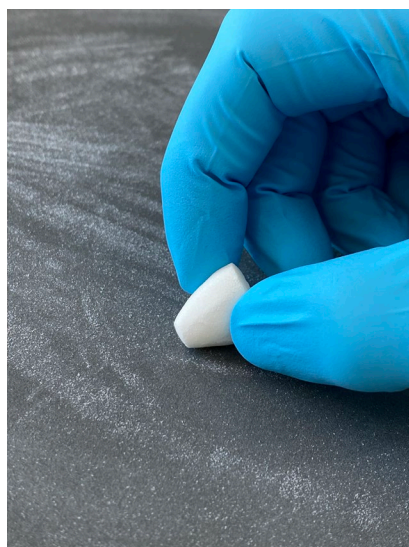
Figure 14. Dry pad worked by abrasive paper, © Ricotta Nicola.

- optimization of the pad production protocol using abrasive paper (Fig. 14) as suggested by Jorge Gonzalez Frutos. The size, shape, and physical integrity of the pad are critical in order to make LSV measurements reproducible. After cutting the wet PVFM pad using a hole puncher for rubber stopper (to create a cylinder with a constant diameter and no imperfections), the resulting pad is left to dry and the tip is shaped with abrasive paper.

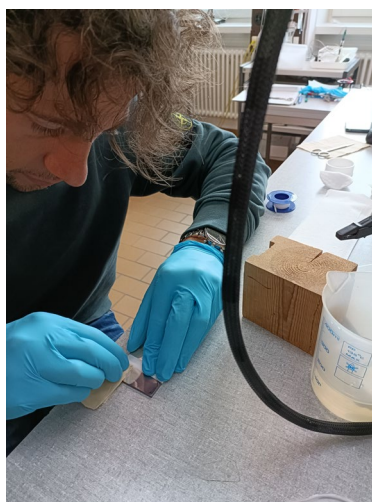
Figure 16. Burnishing the coupon with cotton cloth, © Degriigny Christian.

- burnishing of the surface after electrolytic cleaning (Fig. 16). The reduction of tarnish in metallic silver may result in surface whitening and matting. This undesirable effect can be corrected by mechanical action with cotton cloths until the desired effect is achieved. In this specific case, we did not manage to remove entirely the whitening phenomenon. It has to be noted that if it systematically occurs on electrolytically cleaned tarnished mirror-polished coupons, we observed it less on real objects.

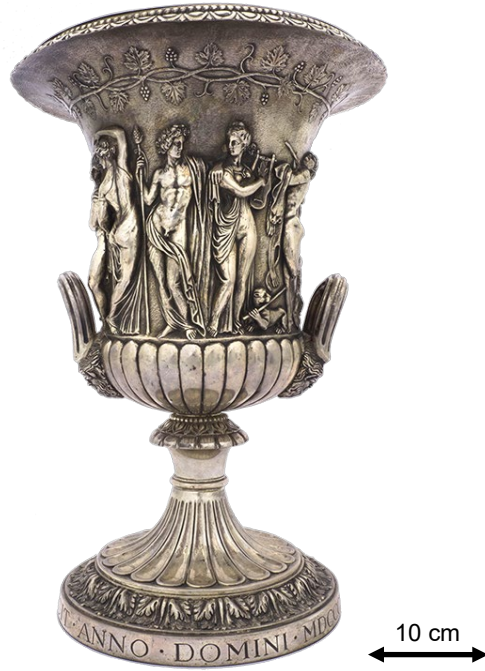
Figure 17. Valadier cooler, XIX century, © Ricotta Nicola.

These results form the basis for the development of the investigation and restoration phases of silver-based alloy artifacts. The first objects on which the protocols studied so far will be applied will be a Valadier cooler (Fig. 17) and a bas-relief with the Last Supper (Fig. 18) from the Tesoro dei Granduchi, Gallerie degli Uffizi, Florence.

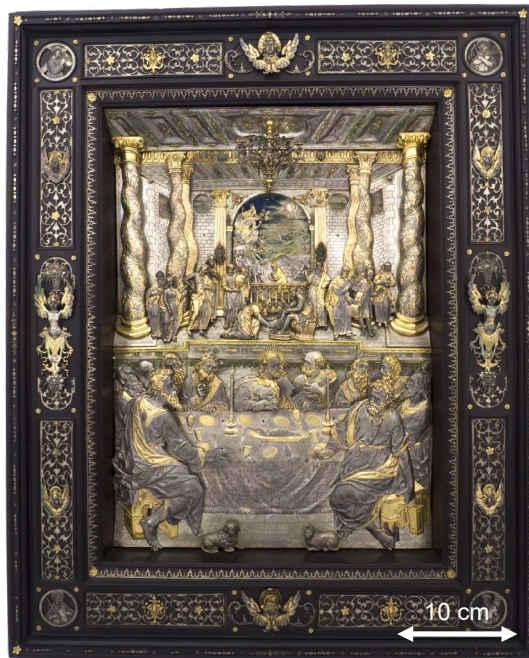
Figure 18. Last supper, Matthias Walbaum, XVI century, © Ricotta Nicola.
