Report on the outcomes of a Short-Term Scientific Mission

Action number: IG16215

Title: “Application of ENDLESS Metal analytical tools in the context of Polish Cultural institutions: National Museum, Second World War Museum and the National Maritime Museum, Gdansk”

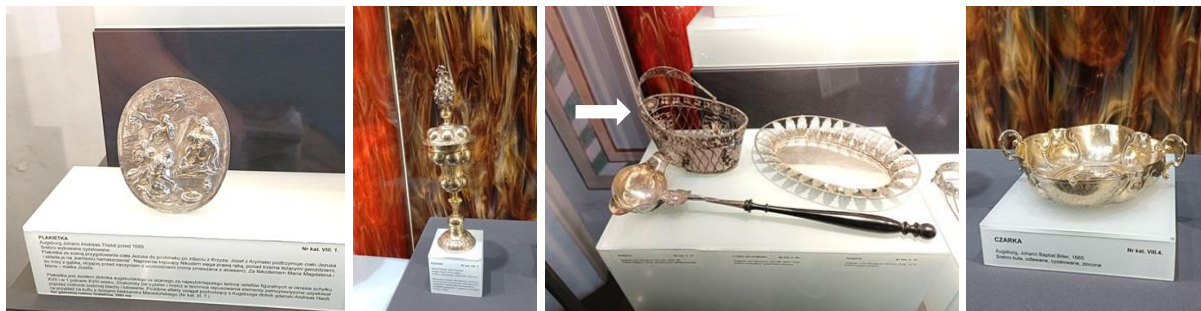
Day 1 (19.06.2023): testing Pleco on objects of the Silversmiths' gallery to detect the presence of copper in silver through Linear Sweep Voltammetry (LSV) plots

A few objects from the Silversmiths' gallery (see pictures above) were kindly proposed by Anna Baranowska-Fietkiewicz (ABF - Metals curator) and documented by CVW using Dinolite microscope. These objects were:

- A silver-based plate from Augsburg (Inv. Kat.VIII.1, Johann Andreas Thelot, mid. 17th c.)
- A gilded silver-based goblet from Nuremberg (Inv. Kat. VIII.3, Hans Bertolt, 17th c.)
- A silver-based wire basket with filigrees (Inv. Kat.V.15, Carl Benjamin Schultz, 1834-1836)
- A partly gilded silver bowl from Augsburg (Inv. Kat. VIII.4, Johan Baptist Biller, 1665)

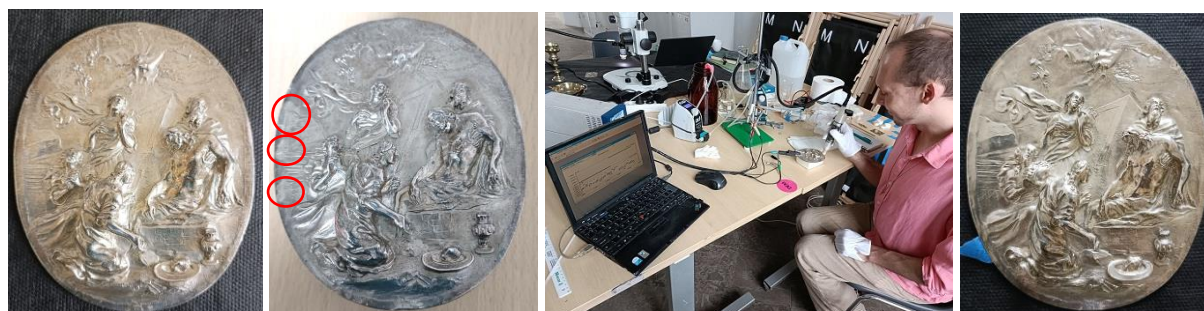
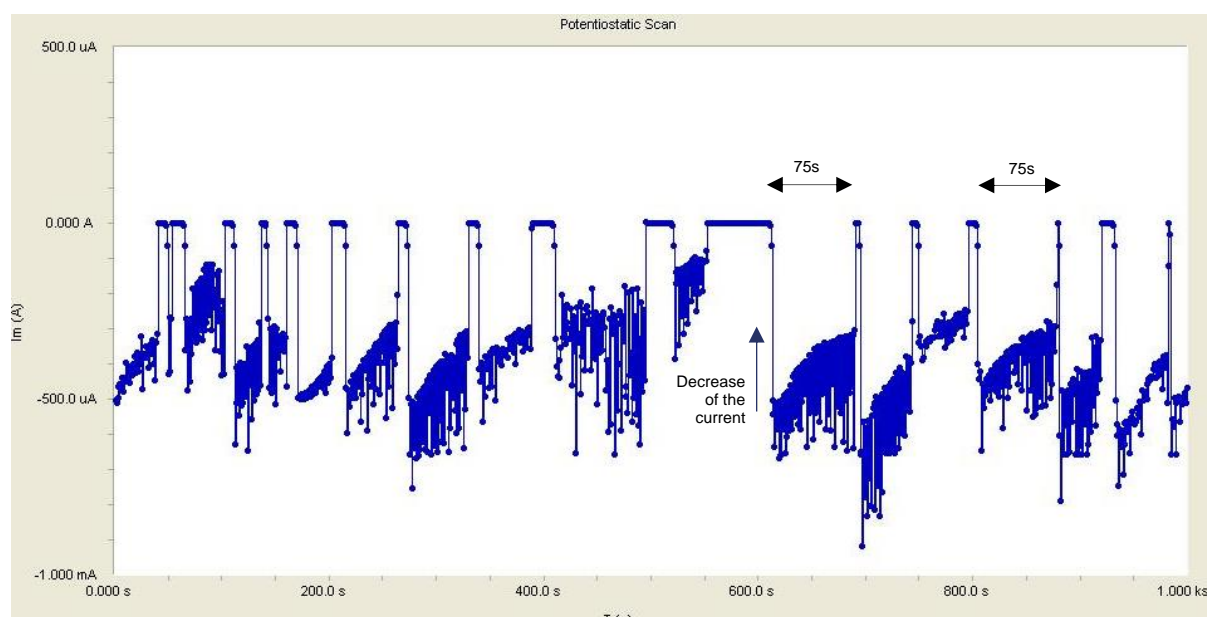
- *Silver-based Augsburg plate*

No reduction peak could be seen on LSV plots even by decreasing the extraction flow to 20mL/min. Still the area investigated looked cleaned (2nd picture from the left below). These areas were clearly visible on purpose since CVW wanted to test the cleaning abilities of Pleco. Therefore, potentiostatic plots were performed first at -1V/GC (middle of the reduction peak) and then at -1.2V/GC (see the plot below) to speed up the reduction process (max. of the reduction peak on artificially tarnished Ag coupon, see above). The reduction is efficient after 30 to 75s. Most of the tarnish of the front plate could be cleaned using Pleco dynamically (3rd picture from the left below). Some black spots remained after cleaning which could be due to the presence of copper corrosion products (1st picture from the right).

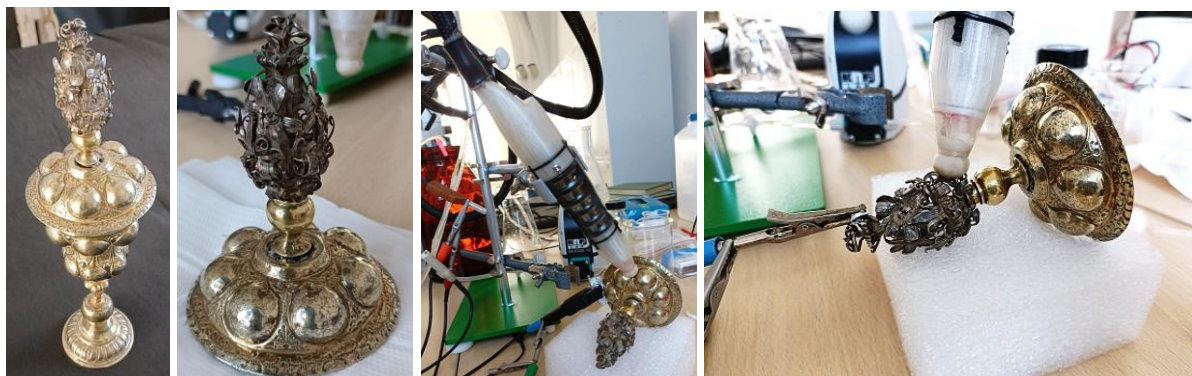
- *Gilded silver-based goblet*

Only the cover was considered and LSVs were performed as discreetly as possible both on the gilded cover and its silver-based floral decoration (extraction flow of 20mL/min.).

In both cases only the $\text{Ag}_2\text{S} \rightarrow \text{Ag}$ reduction peak could be identified (see the LSVs above). This seems to indicate the presence of a low concentration of copper in the silver-based alloy (< 3% ?) but due to the slight tarnish, this result should be validated by X-ray fluorescence (XRF) analysis.

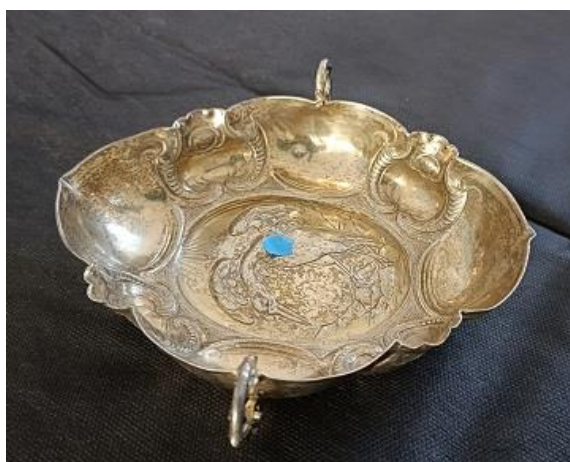
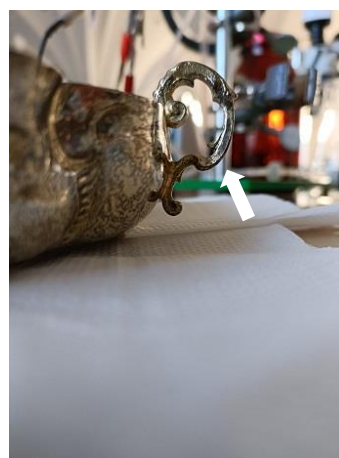
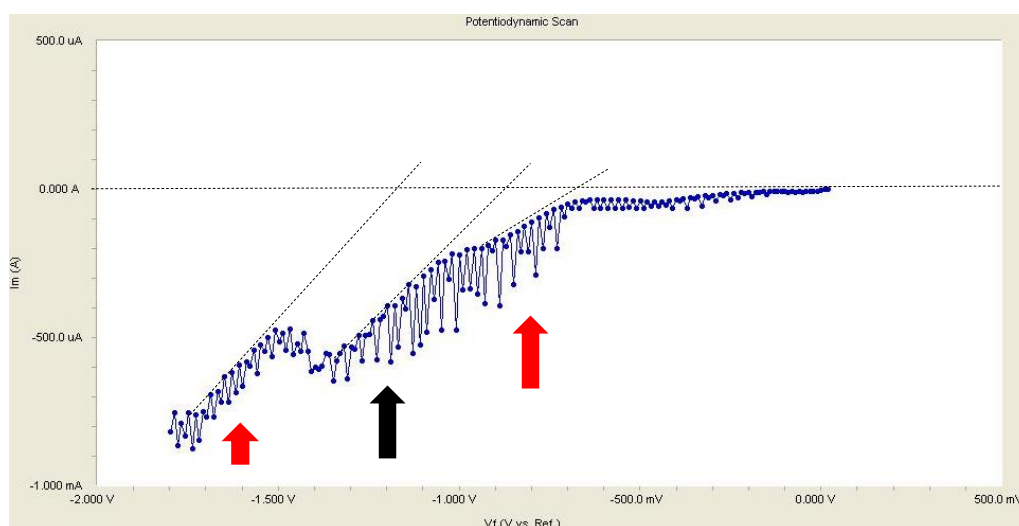
- *Partly gilded silver-based bowl*

Once again, an LSV was performed as discreetly as possible on one of the handles of the bowl (see the right picture and plot below). This time three reduction peaks were observed. In addition to $\text{Ag}_2\text{S} \rightarrow \text{Ag}$ reduction peak, a first small peak could be attributed to the reduction of a Cu-O compound, while the peak with a max. at -2V/GC could be due to the reduction of a Cu-S compound. These two Cu-based reduction peaks indicate, apparently, that the silver-based alloy contains more than 3% wt Cu.

As said above, the fluctuations of current being quite large, a higher extraction flow would have made the reduction peaks clearer.

As a conclusion of these tests, we clearly see the possibilities of Pleco to identify the presence of not of large amounts of copper (around 3% in weight) in the silver-based alloys.

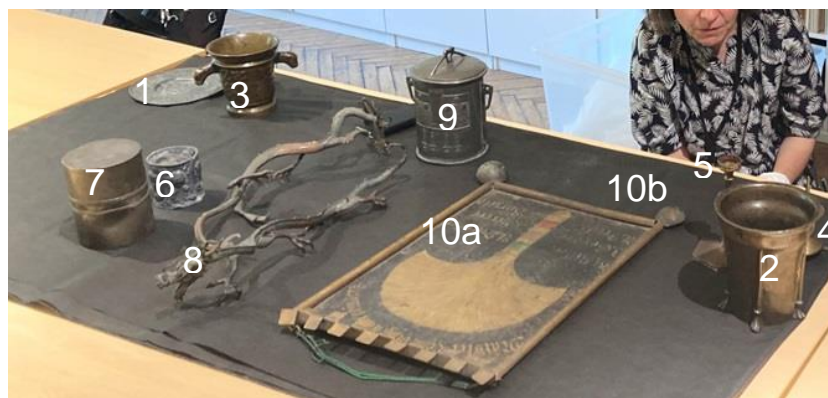
A few objects were selected by Anna Baranowska-Fietkiewicz (ABF) and we questioned the MiCorr application and its search engine “By visual inspection” to identify them.

The following table describes the objects (information provided by ABF) and gives the results proposed by MiCorr. Three objects are questionable (highlighted in yellow) and would need to be analysed by XRF. Their core metal is supposed to be zinc-based alloys.

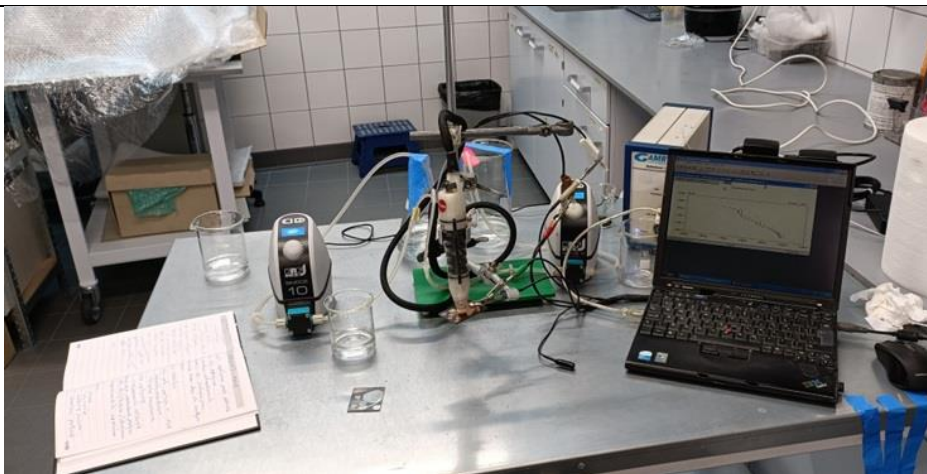
Similarly to the first day, the experimental parameters were determined using LSV plots on silver 99.9% and silver 92.5% coupons tarnished artificially with boiled eggs. After checking the glassy carbon (GC) electrode in 1% KNO_3 (21mV/Ag-AgCl) and sealing properly the Pleco electrolytic cell, we adjusted the extraction flow of the electrolyte to visualise properly the $\text{Ag}_2\text{S} \rightarrow \text{Ag}$ reduction peak (-0.85V/GC) on Ag 99.9 coupon. We passed then to the detection of the additional Cu compounds reduction peaks on Ag 92.5% coupon. It appeared that the best results were obtained for an extraction flow of 20mL/min. (supply flow of 10mL/min.).

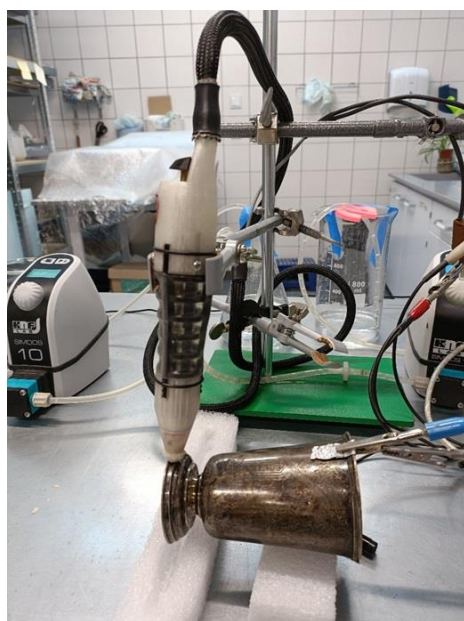
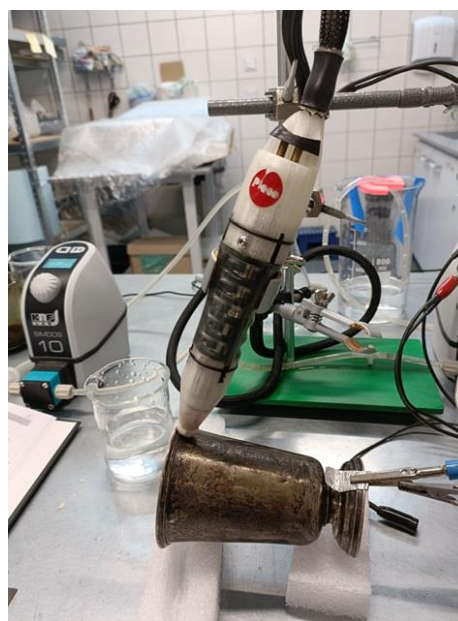
LSVs were then performed on the cup.

The first Cu-compound reduction peak (Cu_2O , red arrow) is difficult to visualise. The next reduction peak is probably the reduction of Ag_2S (black arrow). Reduction peaks starting at a potential just below E_{corr} could be attributed to silver chloride (?).

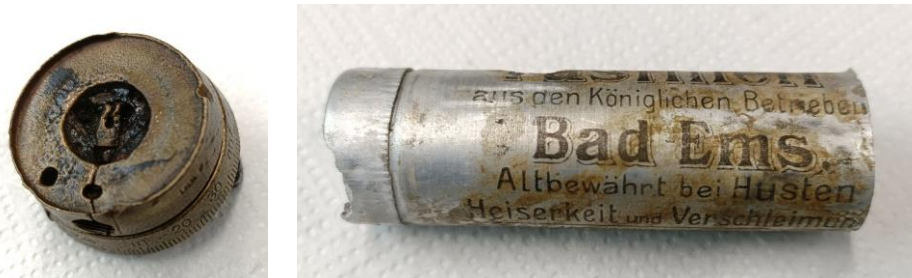
Two objects were selected by MRU: a copper-based part of a Soviet missile or bomb fuse from World War II found by archaeologists in Westerplatte, Poland (left picture, below) and an aluminium-based used box with salt pills from World War II (or before the war), also found in Westerplatte (right picture, below).

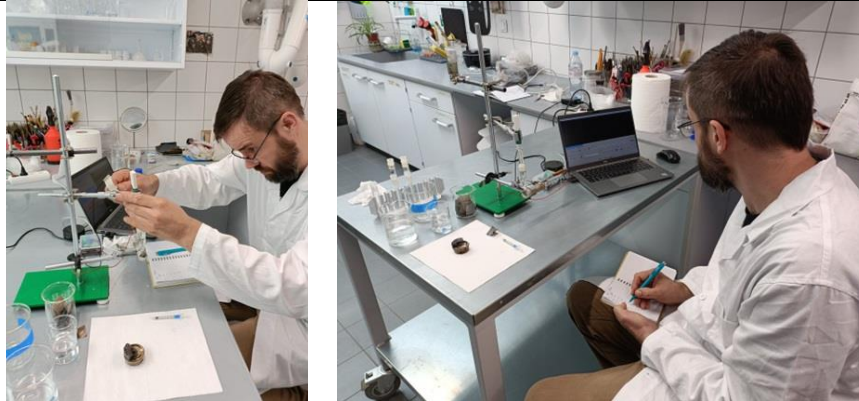
After a reminder of the different steps of the measurement protocol, Mateusz Rutkowski carried out most of the measurements himself.

Interpretation of the data using the MiCorr database (135 entries) seems to show (fairly good matching: first proposal with a distance of similarity – Dsim. of around 400) that the part of a Soviet missile or bomb fuse is a quaternary alloy with low concentrations of Zn and Sn (below 10%) and Pb (not below 1% however, due to the instability of the corrosion potential measurements, see the two proposals on the left below). At this stage, it is difficult to determine whether Zn or Sn is more important. As for the pills box, the matching is not good (first proposal with a Dsim. of more than 3000) but it seems that the metal is made of a relatively pure aluminium sheet (see the two proposals on the right below).

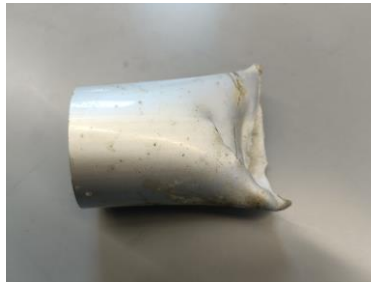
Preliminary tests were carried out on a piece of aluminium alloy, the top surface of which was clearly anodised (see picture above). A discussion with AFO about the best measurement area led us to work on the edge of the tube, but we were unable to obtain the electrical contact required for our measurements.

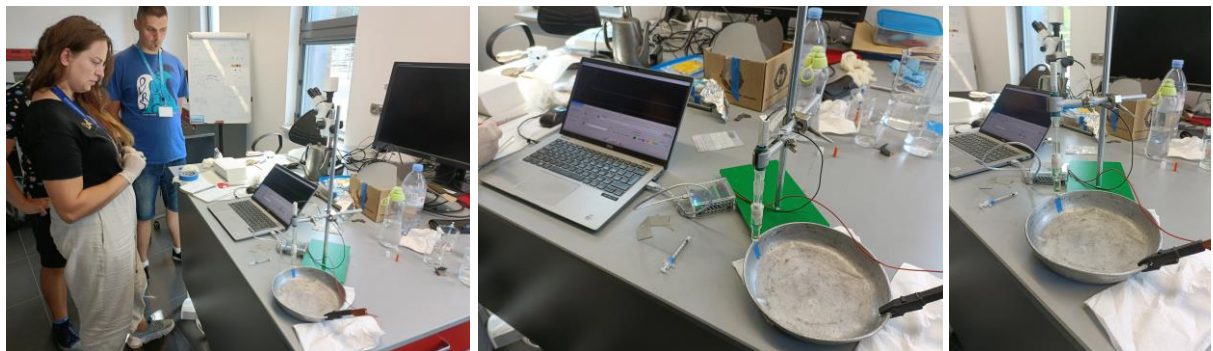
The first results in Evian mineralised water were not reproducible (see the series of plots on the left below). CDE explained that this was due to the presence of a corroded metal surface which electrochemical behaviour changed after each polishing step. A discussion followed then on how far to go with the polishing process so to get reliable results. Obviously, a better reproducibility of results was obtained with 1% KNO_3 during the second series of measurements (series of plots on the right below).

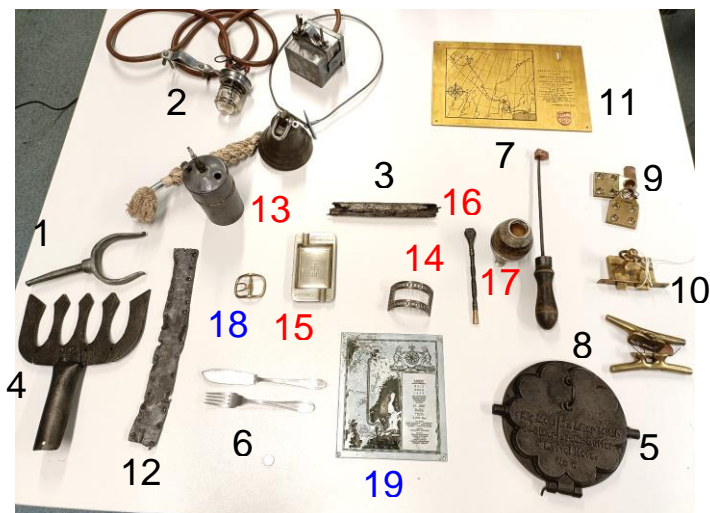
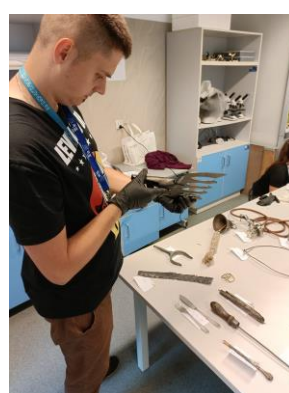
- Magnetic iron-based objects: 1 & 2 (steel), 3 & 4 (wrought iron), 5 (white (?) cast iron)
- Non-magnetic iron-based objects: 6 (austenitic stainless steel)
- Red and yellow alloys: 7 (pure copper), 8 (bronze ?), 9 (brass ?), 10 (mixture of brass and bronze ?) and 11 (mixture of brass and copper)
- Weight: 12 (lead)

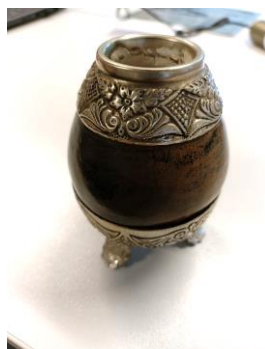
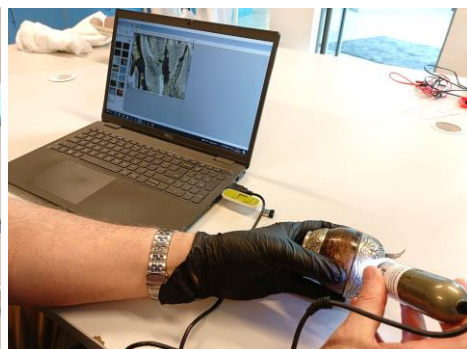
16 and 17 were the most challenging objects. They work together. A closer look at 16 and the assistance of MiCorr revealed that the decorated tube was a heavily tarnished silver-plated brass with a copper-based spout. The accompanying vessel (17) also seemed to be made of silver-plated brass, but closer examination under a Dinolite microscope revealed an untarnished whitish-yellowish metal covered, locally with black deposit (see pictures below). We then hesitated between German silver (Cu-Zn-Ni alloy) and nickel-plated brass. But Catia Viegas Wesolowska, who turned up at the beginning of the afternoon, immediately recognised in these two objects a Yerba Maté set (cup or maté and its filtering straw or bombilla), certainly from Argentina. Similar Yerba Maté set can be found on the web. Often, they are mentioned to be made in Alpaca (German silver). Objects 18 and 19 were not considered.

Finally, we have proved once again that collaboration between different communities (curators, conservators and conservation scientists) can speed up the diagnostic process. The examination of the Yerba Maté set of the National Maritime Museum clearly demonstrated this. All the participants recognised this essential contribution, which should encourage us to systematically promote these partnerships, which unfortunately are all too rare because of everyone's workload.
